# The Performance of Carbon Fibre Reinforced Polymer Strengthening During a Real Fire

# THE PERFORMANCE OF CARBON FIBRE REINFORCED POLYMER STRENGTHENING DURING A REAL FIRE

*Tim Stratford, Martin Gillie and Jian-fei Chen*  
*School of Engineering and Electronics, The University of Edinburgh*

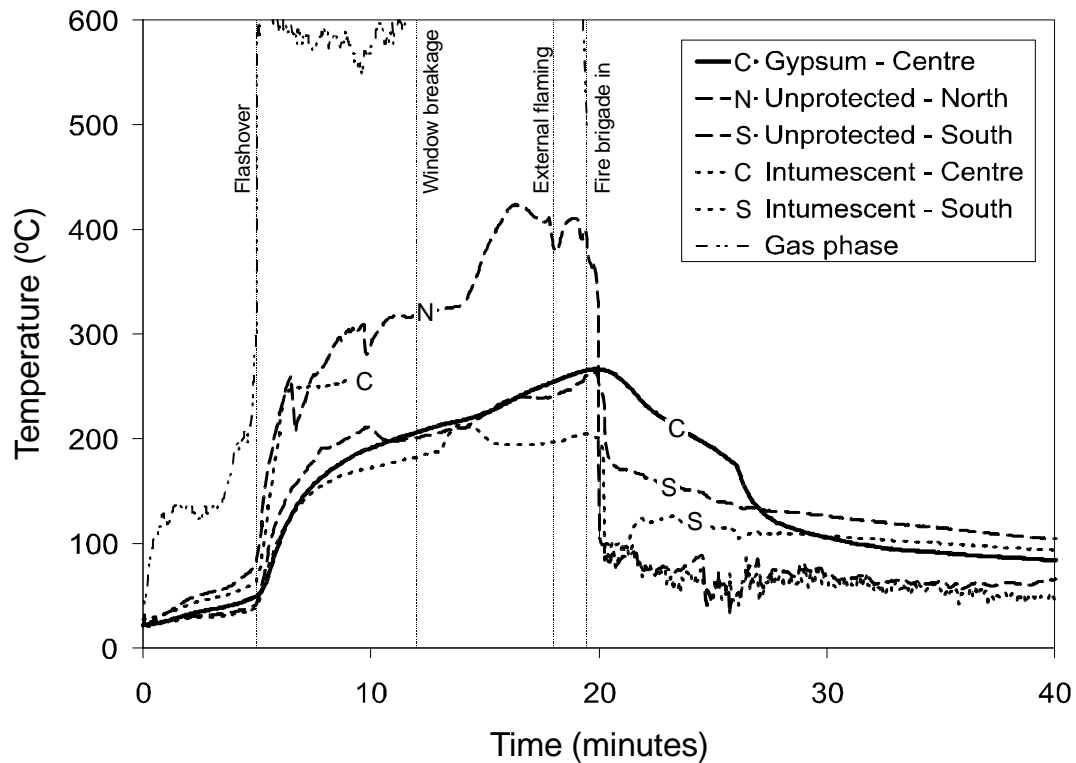
Figure 6a: Bondline temperatures - plates

Figure 6 also shows the temperatures recorded by the bondline thermocouples, for each strengthening type and at each position (north, centre and south). There were a few inactive thermocouples (not shown), and the readings for 3 thermocouples (gypsum-centre, intumescent-north and intumescent-centre) are erroneous. Note that some of the readings in Figure 6 were taken after a plate had separated from the ceiling. In all cases the bondline temperature was well above the glass transition temperature of the adhesive. As expected, the bondline temperatures are highest in the unprotected plates; however, even with gypsum-board protection, the glass transition temperature was reached within a minute after flash-over. This was much more rapid than previous furnace-based research (eg: [5]). Although the protection is not directly comparable, these furnace-based tests suggest that it takes in the order of 20 minutes for a similar temperature rise. Without further analysis it is not possible to draw comparisons between the plate and NSM temperatures.

The bonded FRP strengthening installed in Dalmarnock Test 1 are the first in a ‘real’, flash-over fire. The results and preliminary analysis have demonstrated the vulnerability of the bonding adhesive during a fire; the bondline temperature greatly exceeded the glass transition temperature in all tests (with and without protection). Furthermore, this temperature was reached far more quickly than furnace-based testing has suggested.

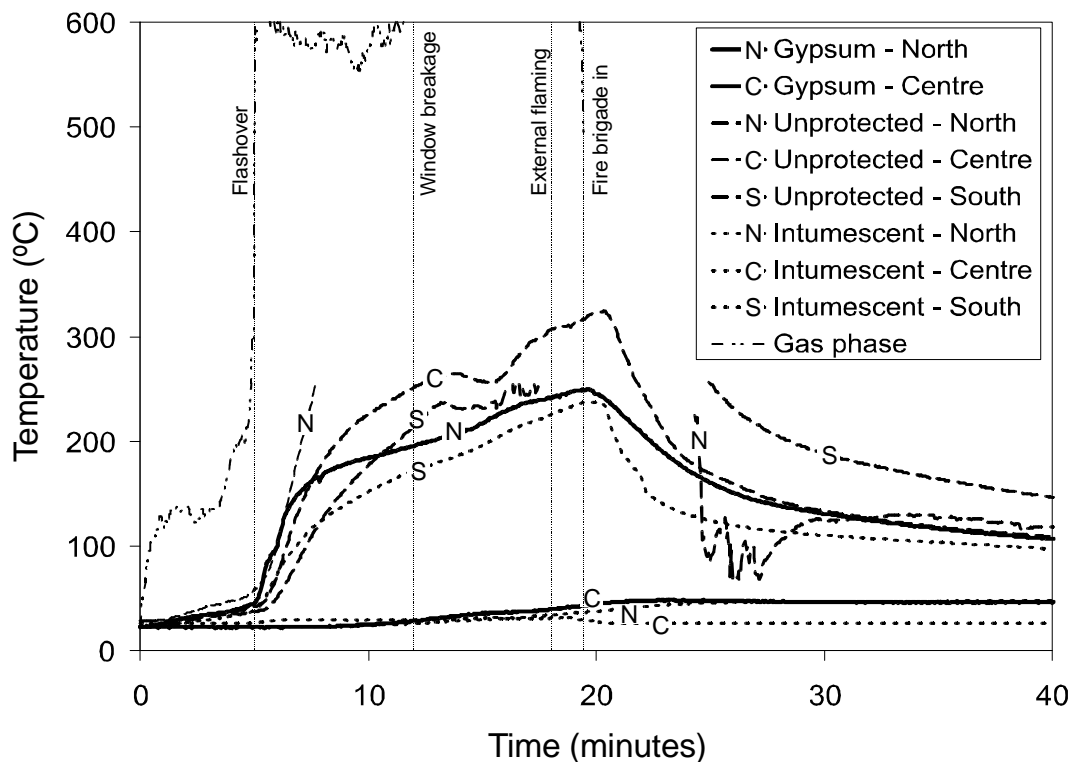
Figure 6b: Bondline temperatures - NSM

NSM strengthening has superior integrity to plate strengthening during a fire. The surrounding concrete would be expected to draw heat away from the adhesive, but further analysis of the test data is required to investigate this.

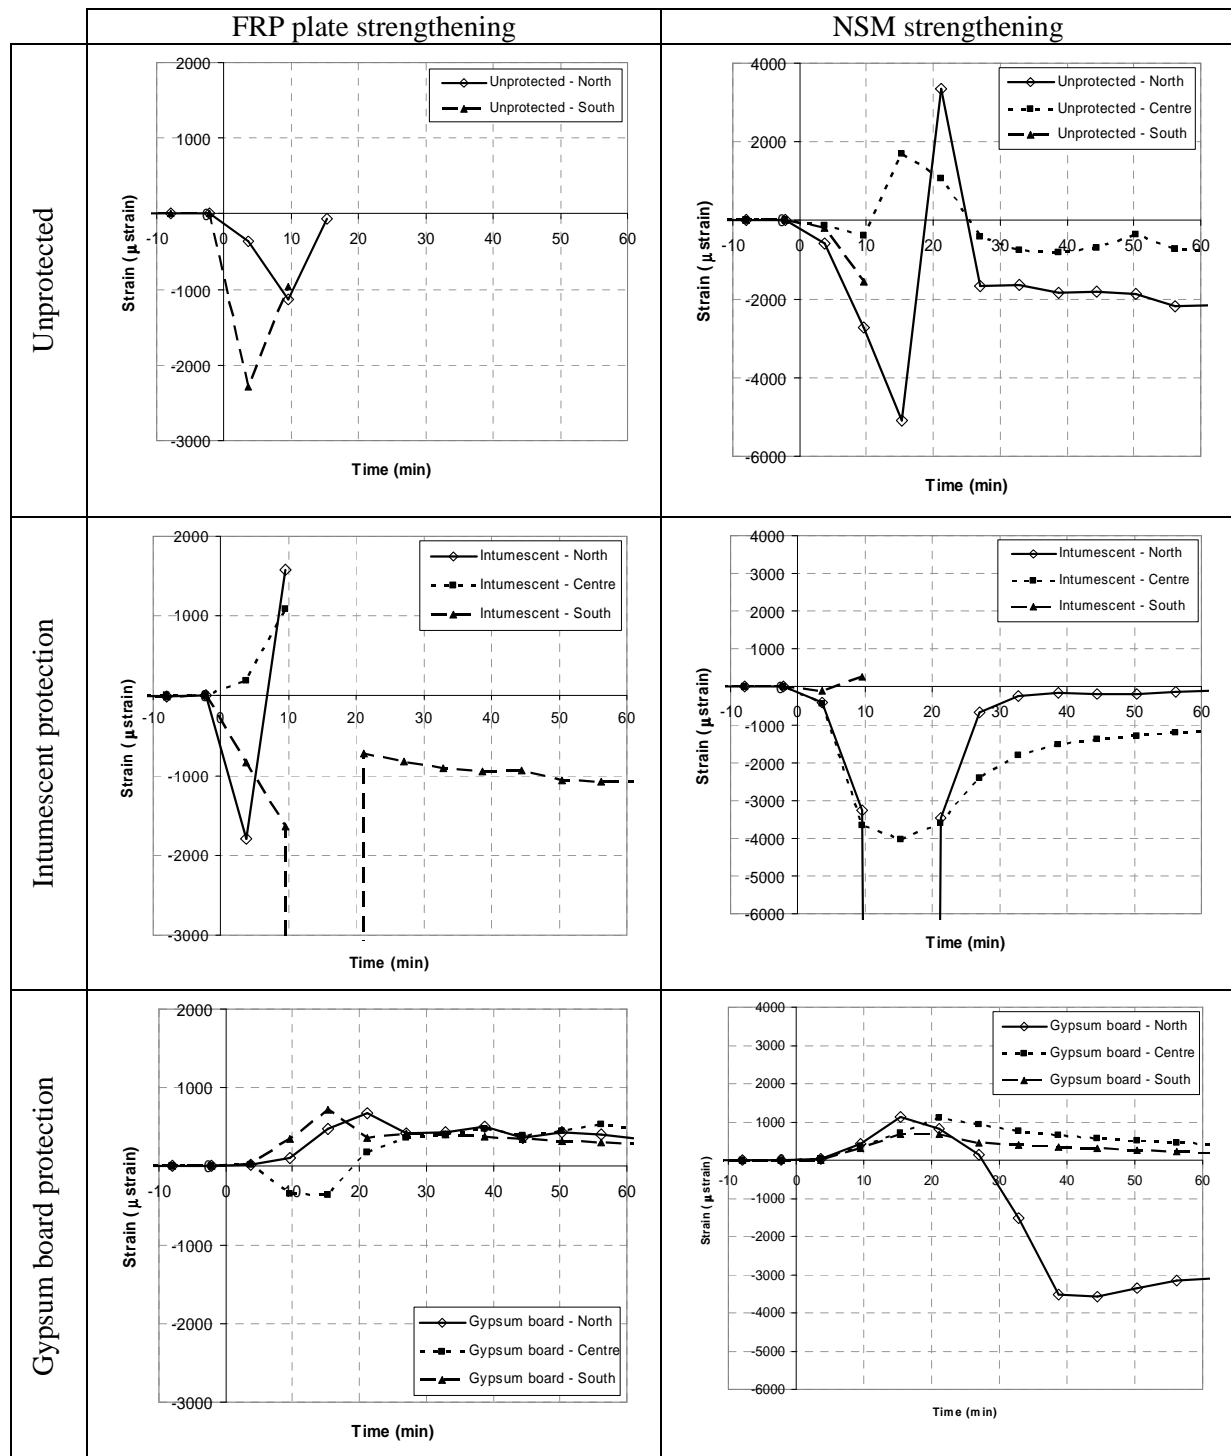
**Figure 7: Uncorrected FRP strain measurements**

Figure 7 shows the strain gauge results, presented here before correction for temperature effects. These strain results are all due to thermal effects: (a) thermal expansion of the FRP component, possibly in composite action with the concrete, (b) differential thermal expansion between the gauge and the FRP, and (c) apparent strains due to electrical effects in the gauge. Future work will use thermocouple readings adjacent to the strain gauges to remove components (b) and (c), but this has not yet been carried out with sufficient rigour to present the results here. It is important to note that the strain gauges and gauge adhesive were only intended for use up to 200°C, consequently the correction will not be accurate and there may have been slip in the gauge adhesive above this temperature. Also, the time resolution of the data is poor, and the negative strains for the intumescent-protected NSM are anomalous.

Nevertheless, the uncorrected strain evolutions in Figure 7 are useful. Separation of the intumescent plate from the concrete, for example, occurred about 10 minutes from the start of the test, but the plate remained in contact at the southern end (confirmed by Figure 5b). The gypsum board protected strengthening have complete strain traces. The negative strains for the north gypsum-protected NSM gauge suggest the FRP has slipped relative to the concrete slab due to adhesive viscosity at high temperatures, but solidified during cooling. Further work, however, is required to analyse these results.
